**BROOKSIDE RESERVOIR
MONTGOMERY COUNTY
INVENTORY NO 168**

**PHASE I INSPECTION REPORT
NATIONAL DAM SAFETY PROGRAM**

**NEW YORK DISTRICT CORPS OF ENGINEERS
JULY 1978**

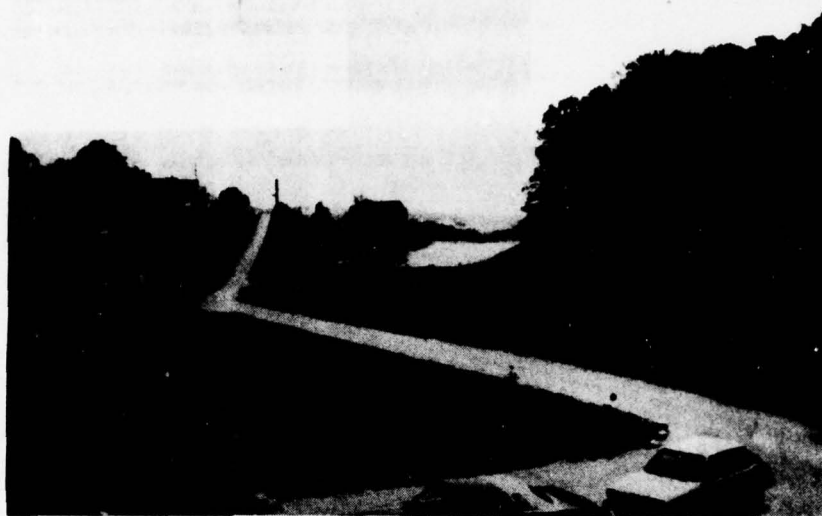
7. View of reservoir and access road from filtration plant.
